PORT AUGUSTA GENERATOR FAILURE

INVESTIGATION REPORT

Capital Planning and Evaluation, Infrastructure
Finance and Corporate Services
SA Health,
Government of South Australia.

Date: November 2016

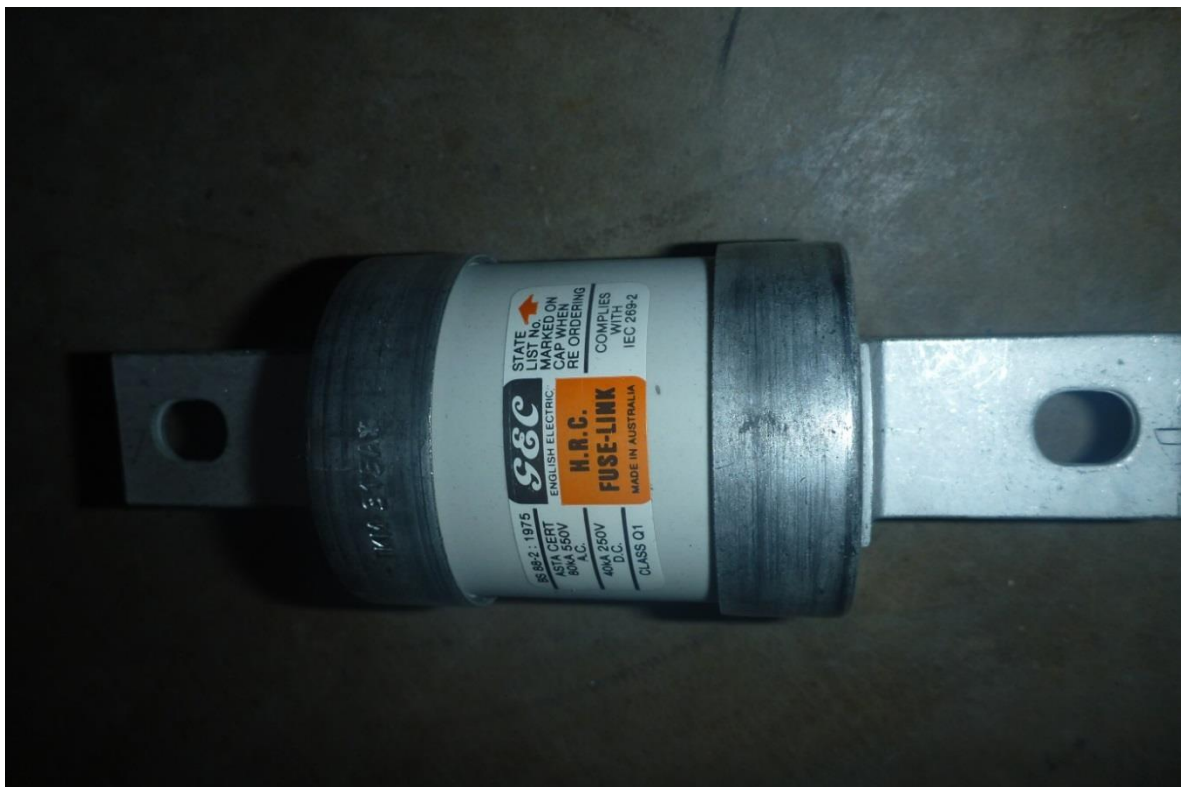
The output from the controller is rated at 170 Kilowatts and the controller is actually protected by 315 amp fuses and as can be seen from the figures in table 1, the engine and alternator should be capable of providing considerably more than the maximum load the fuses are designed to protect against.

As a percentage of the engine output the control panel is approximately 78% of the engine Kilowatt capacity, so at approximately 300 amps of load the engine should only be producing approximately 78% of its power capacity.

315 Amp Fuses Protecting the Output of the Generator

The fuses in the control panel are high rupture fuses which are designed to accept an overload current for a predetermined length of time with the time being inversely proportional to the current (ie higher current shorter time before the fuse ruptures and vice versa).

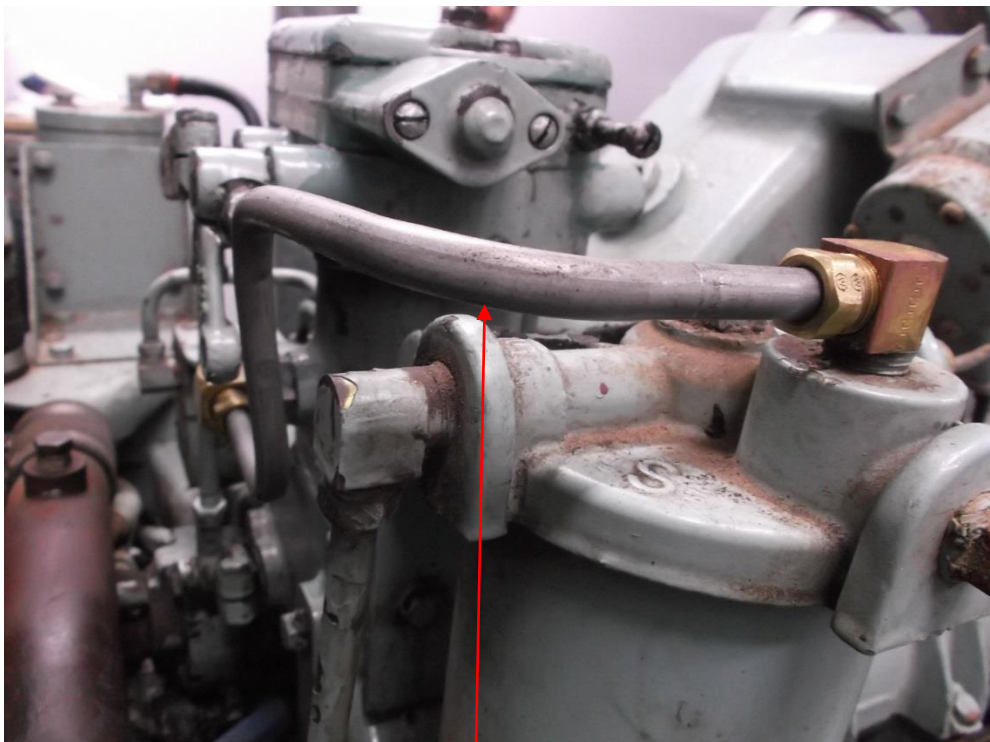
The Honeywell Site Electrician informed us that he restarted the generator after the over temperature shutdown and subsequently noticed an oil leak at the front of the generator engine. The Electrician then shut the generator down and informed his immediate Manager (Honeywell) of the issue.

Butler Mechanical services said that they found a thread at a connector had been stripped at some stage when this pipe had been removed and reinstalled. This meant that the fitting was loose and that through vibration etc a rupture developed at a weak point in the pipe (a bend in the pipe).

Oil pipe that was replaced by Butler Mechanical Services

Butler Mechanical services manufactured a new pipe and installed it to the generator which took approximately 2-1/2 hours.

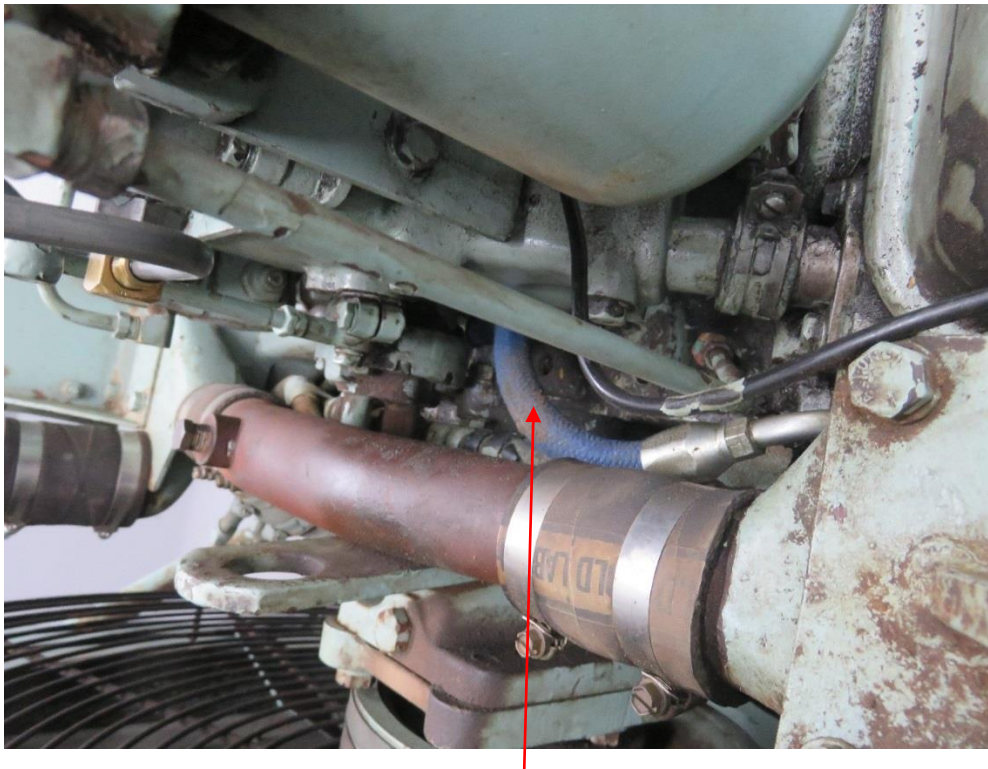
Approximately 1-1/4 hours after the generator was put back into service after the oil leak was repaired, another leak developed which turned out to be a rubber diesel fuel line that ruptured at the front of the generator engine.

We believe that the ruptured fuel line was the original fuel line making it 44 years old and over time had become brittle and reached a point where it failed and ruptured.

Fuel pipe replaced by Butler Mechanical Services

The fuel hose rupture would most definitely be attributed to the age of the hose as the hose would have become brittle over a lifespan of 44 years and failure was inevitable for a rubber fuel hose of this age at some time.

The generator was immediately shut down and Butler Mechanical Services were called out to repair the ruptured fuel line which took approximately 4 hours.

- Replacement of all original pipes and hoses not yet done.
- Accurate records need to be provided as to what is done for each service.
- Monthly test results need to be accurately recorded.
