Flinders Medical Centre
Standby Power Electrical Systems
Post-incident Review
SA Health

1 November 2016
Revision: 2
Reference: 253946

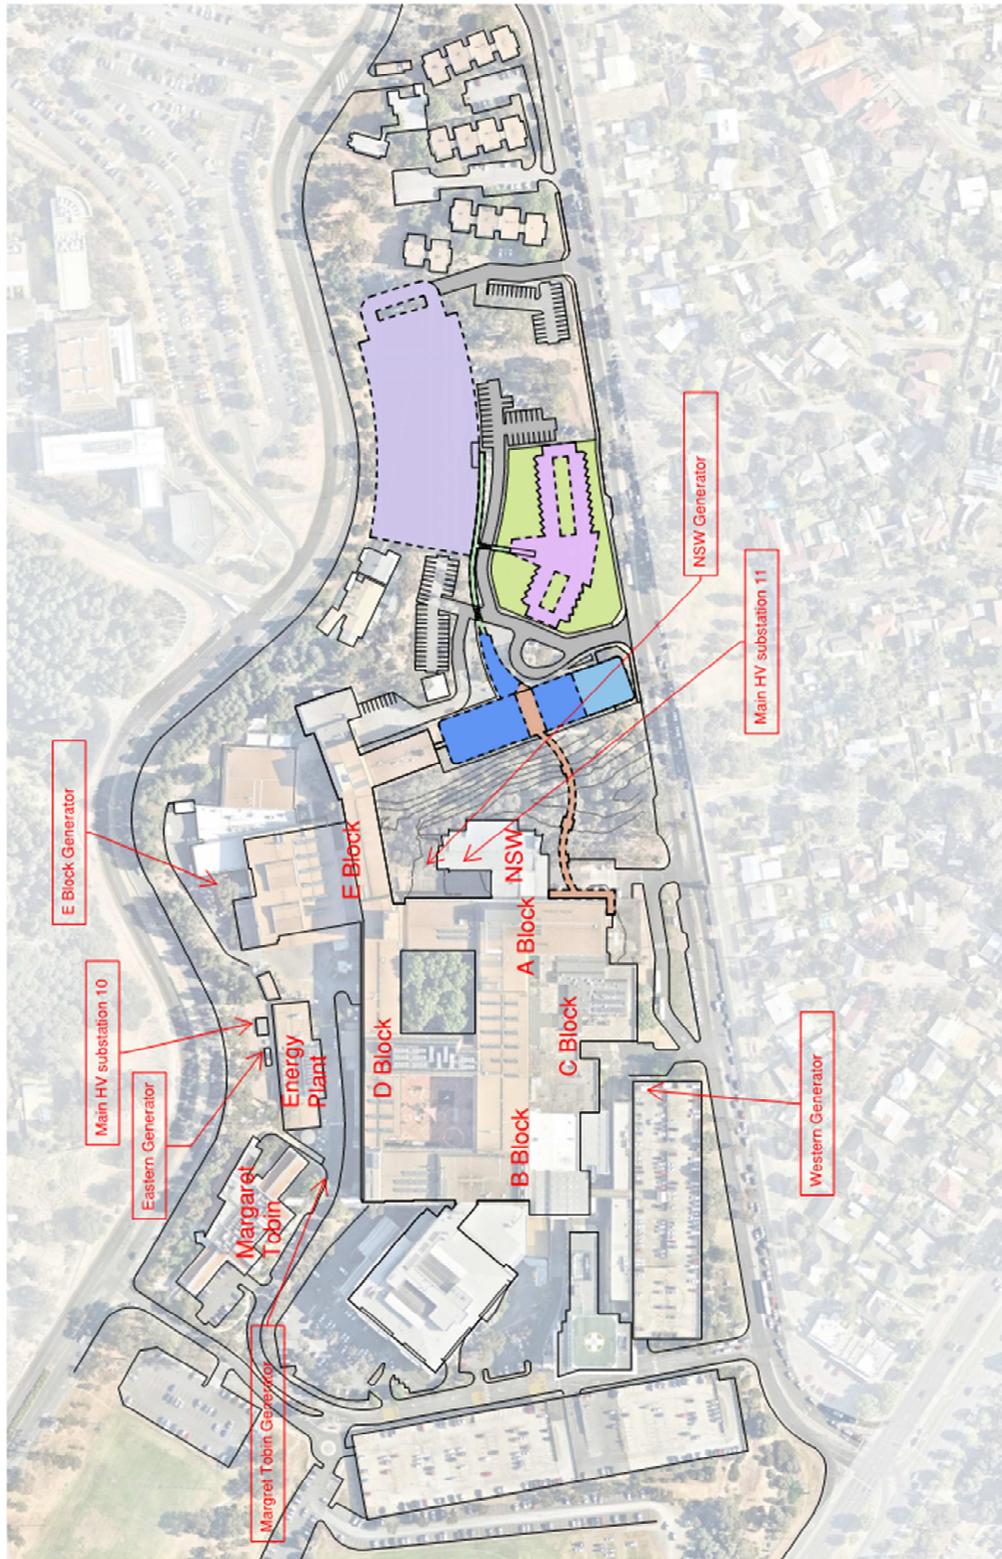
Refer to the site plan below for an overview of the key areas discussed in this report, and to Appendix C for a more detailed view of what functions are located in which areas:

FMC site plan

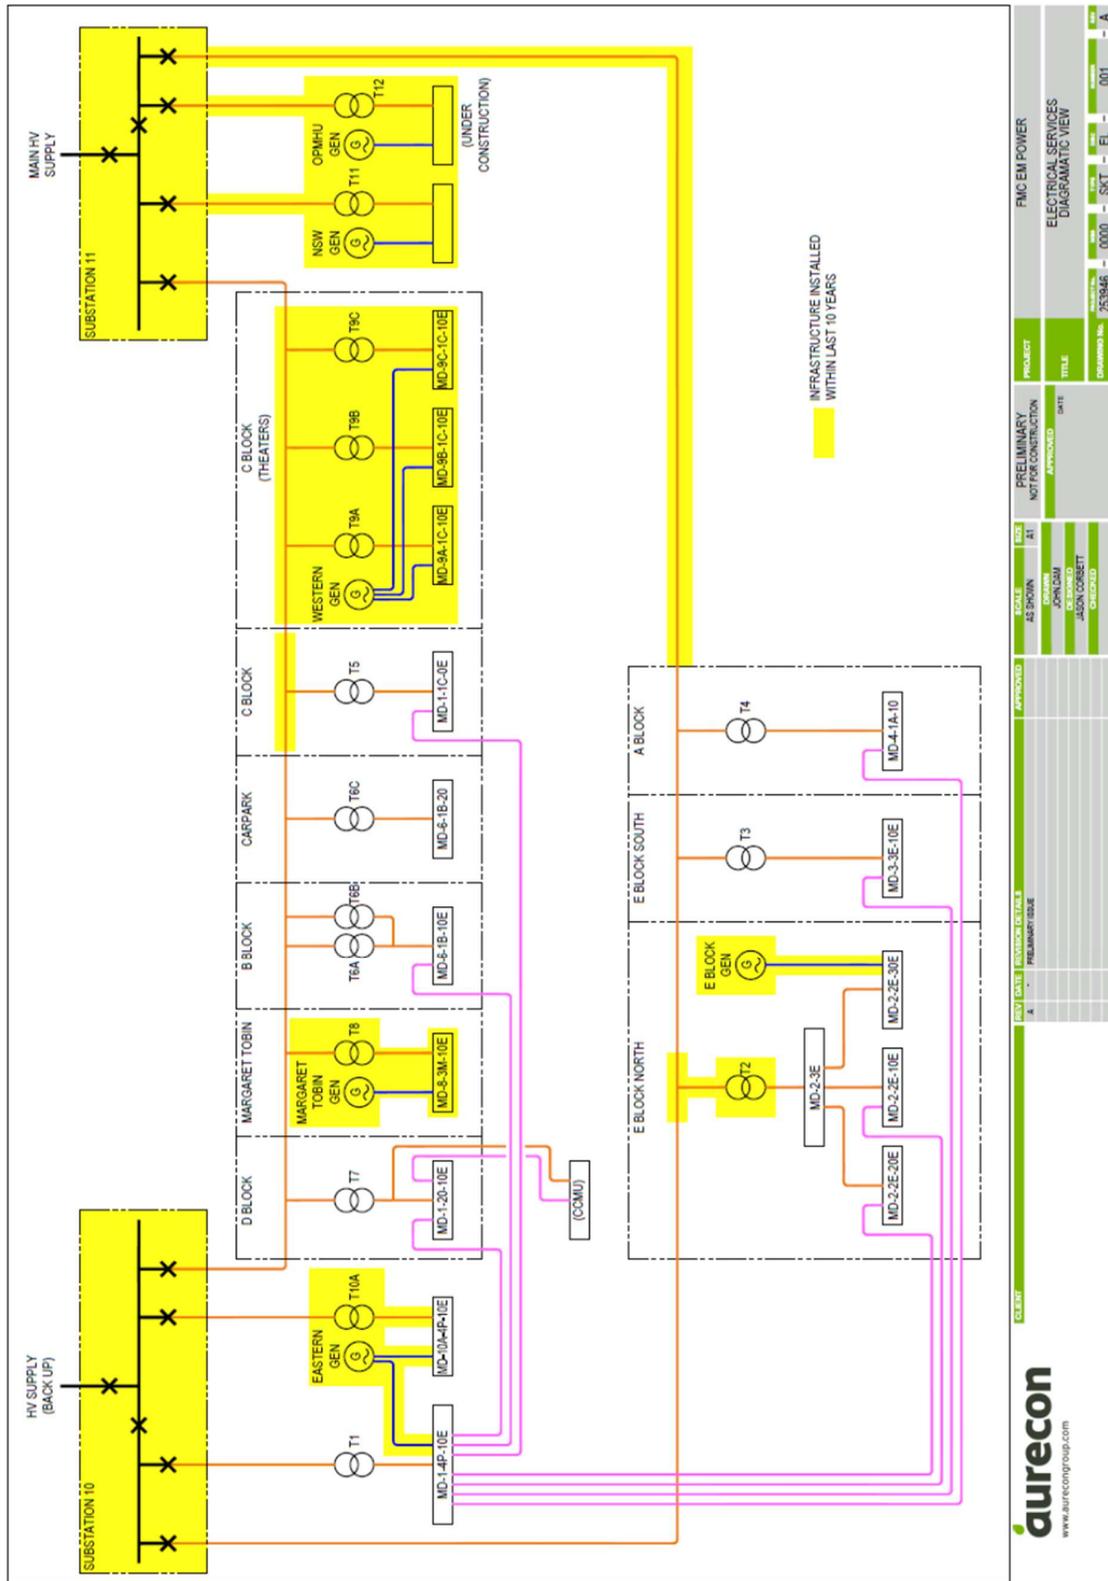
normally configured with supply from the primary HV network supplying approximately half of the FMC through one feeder network, and half through another.

The connection and switching between normal and essential power supplies to various areas of FMC is at essential main distribution boards (MD) at each substation.

FMC emergency power systems (simplified)
