**Flinders Medical Centre  
Standby Power Electrical Systems  
Post-incident Review  
SA Health**

**1 November 2016  
Revision: 2  
Reference: 253946**

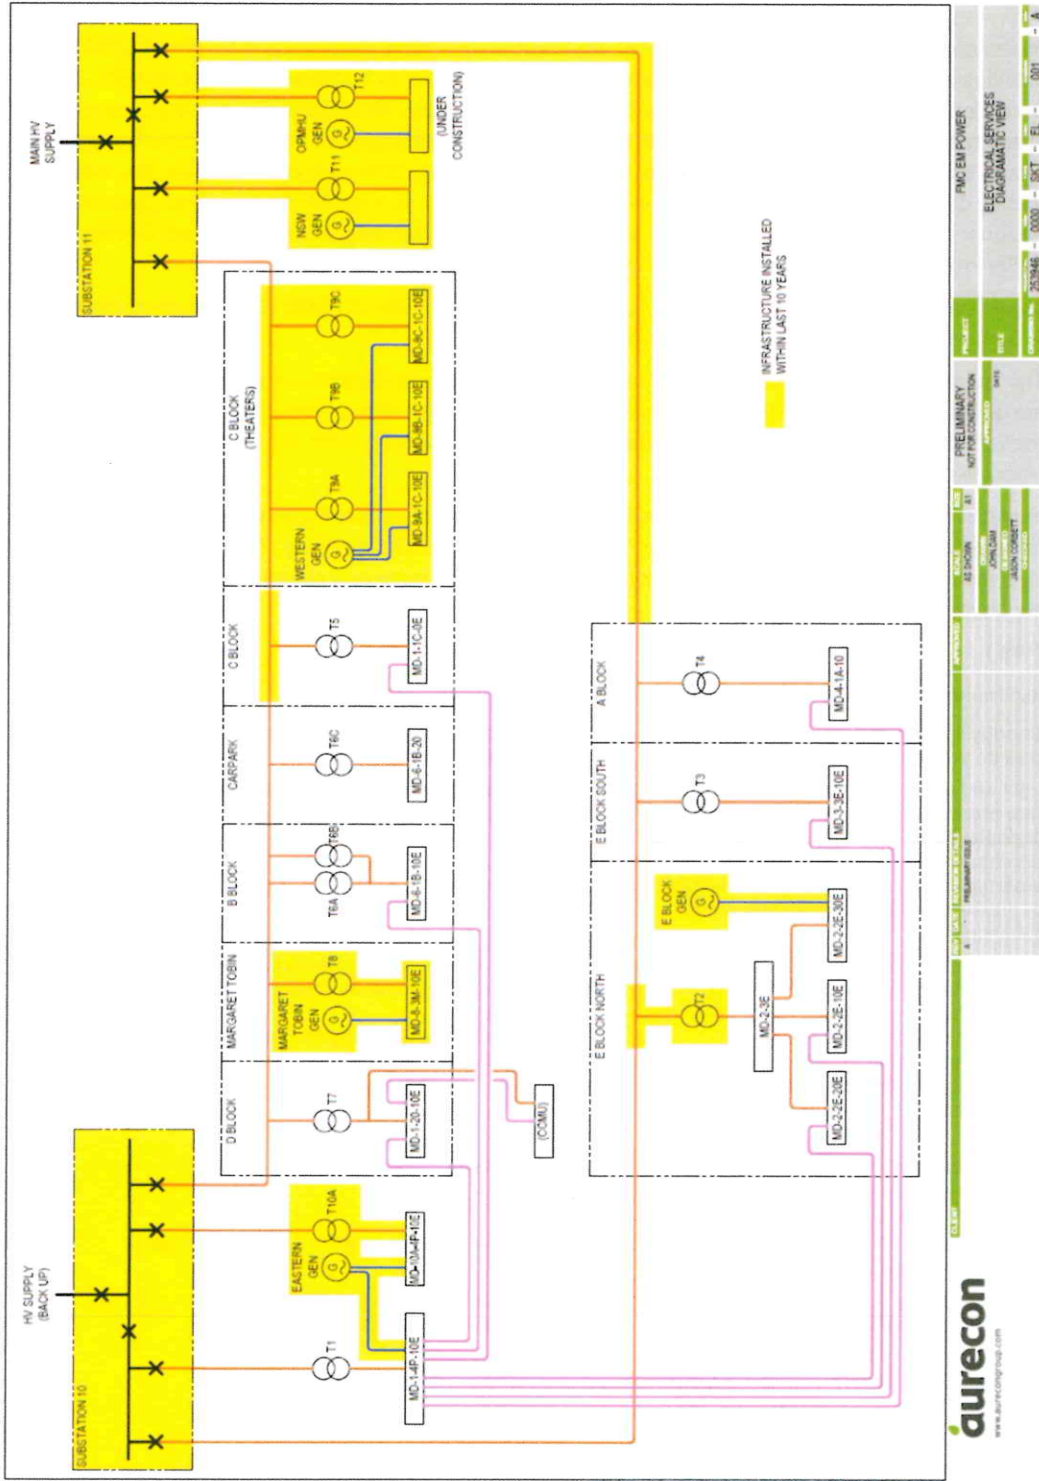
FMC emergency power systems (simplified)

normally configured with supply from the primary HV network supplying approximately half of the FMC through one feeder network, and half through another.

The connection and switching between normal and essential power supplies to various areas of FMC is at essential main distribution boards (MD) at each substation.
